UNDERWATER BRIDGE INSPECTION REPORT

STRUCTURE NO. 2366

MISSISSIPPI RIVER

DISTRICT 2 - BELTRAMI COUNTY, CITY OF BEMIDJI

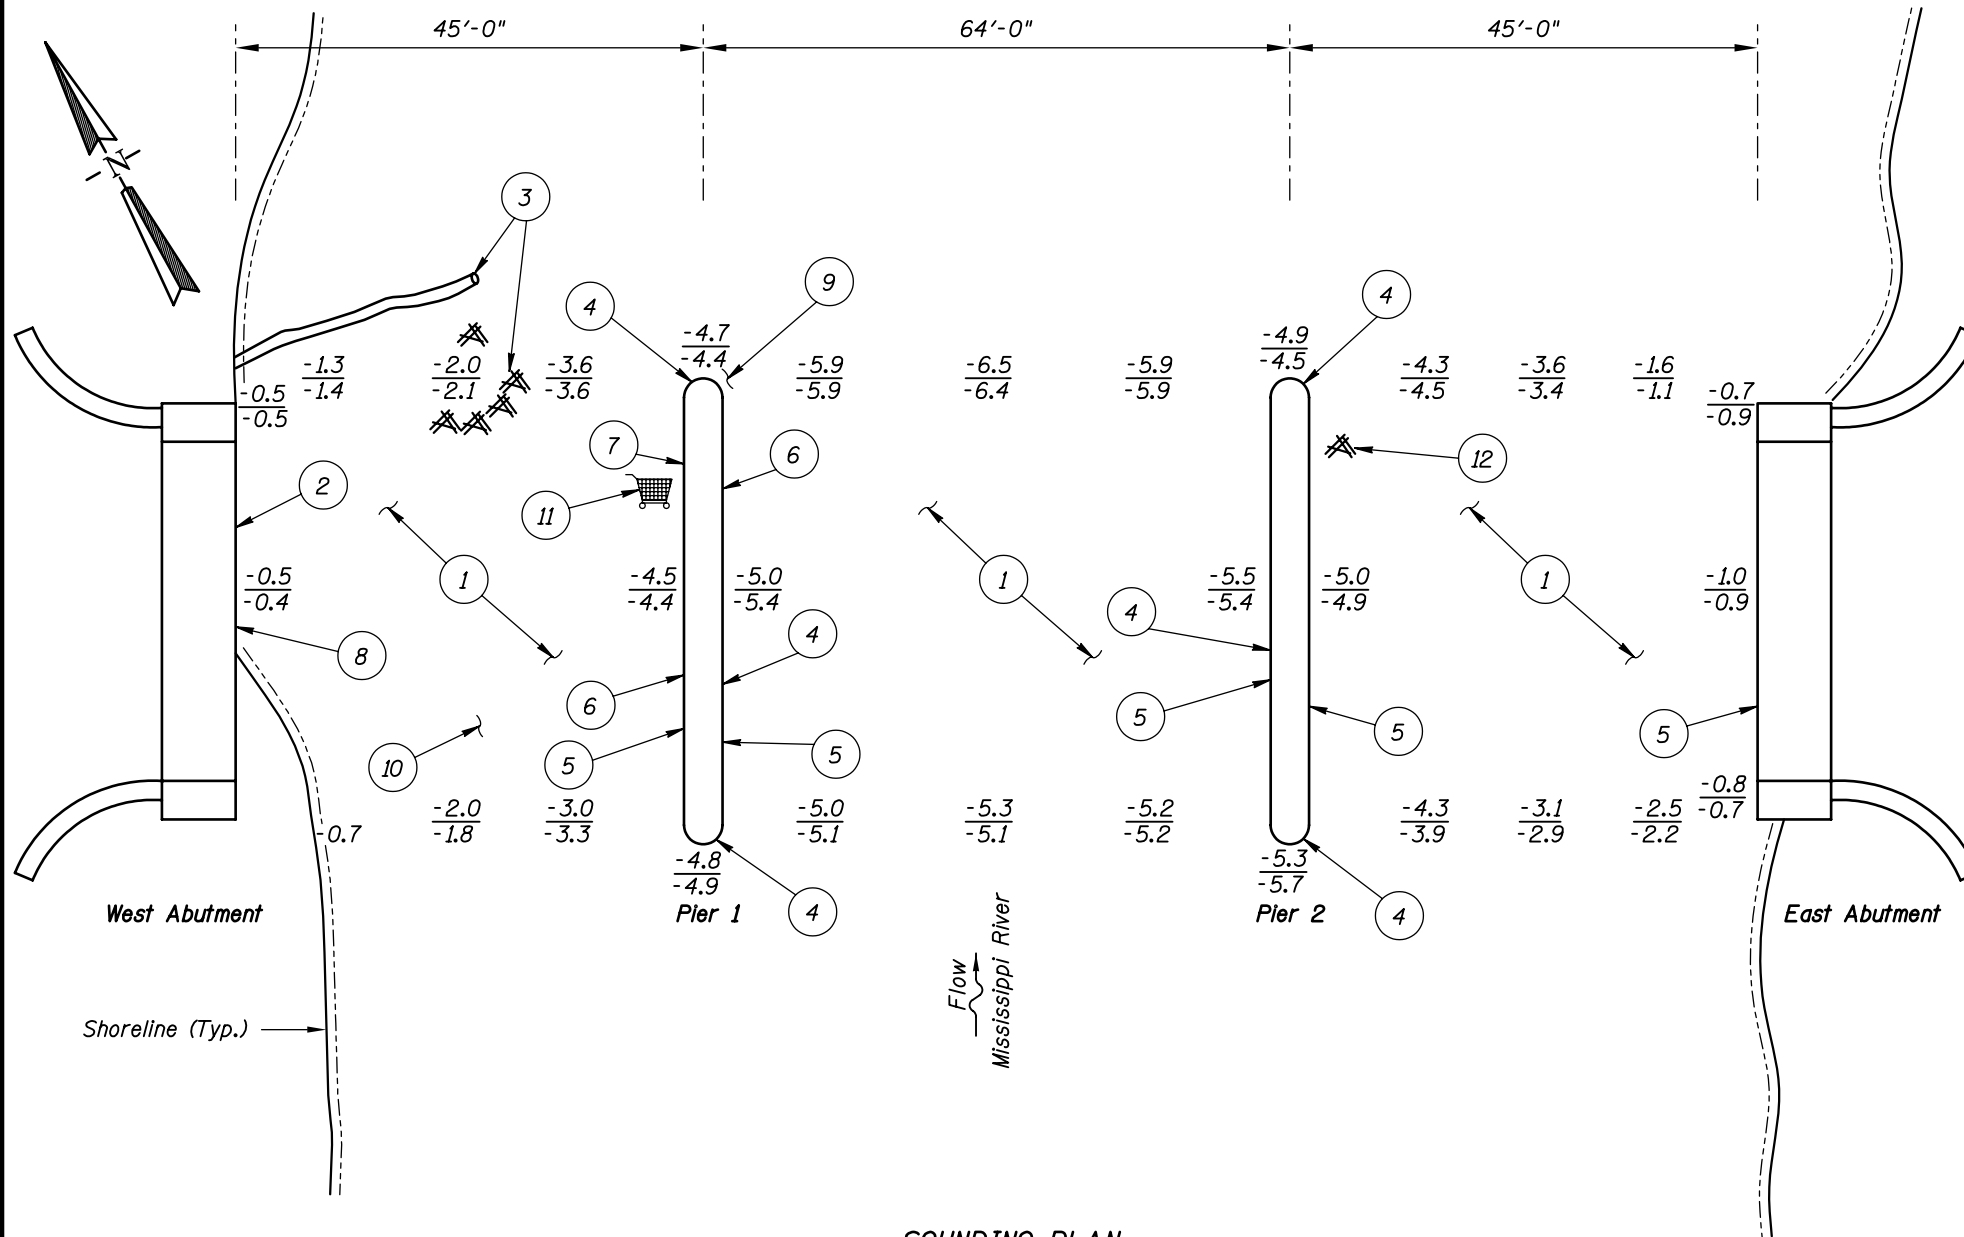
INSPECTION AND SOUNDING PLAN

- 1 The channel bottom material consisted of firm sandy gravel and cobbles with 2 to 3 inches of probe rod penetration.
- 2 Below water concrete was in good condition with a light layer of aquatic growth and no defects of structural significance observed.

- 3 A moderated accumulation of timber debris, including a 20-foot-long by 1-foot-diameter log, was observed extending from the West Abutment to the downstream end of Pier 1.

- 4 Band of scaling, spalling, and section loss around both piers typically located between 2 feet below and 2.5 feet above the waterline, with typical penetrations of 3 to 4 inches and maximum penetrations of 6 to 9 inches. The heaviest deterioration was located around the upstream pier noses and the middle sections of the east side of Pier 1 and the west side of Pier 2.

- 5 Map cracking, hairline to 1/16-inch-wide, and impending spalls were observed from the waterline to 4.5 feet below the waterline.
- 6 A hairline vertical crack with efflorescence was observed extending from the waterline to the channel bottom.

- 7 Area of section loss, 3 feet long by 1 inch high was observed 3 feet below the waterline with 2 inches of maximum penetration.
- 8 Random hairline to 1/16-inch-wide map cracking with light amounts of efflorescence were observed from the waterline to 3 feet above the waterline.

- 9 Random accumulations of riprap observed at the downstream nose of Pier 1.
- 10 A moderate accumulation of assorted garbage (broken glass/bottles, etc.) was observed on the channel bottom between the upstream end of Pier 1 and the West Abutment.

- 11 Shopping cart was observed on the channel bottom.
- 12 8-inch-diameter log was observed on the channel bottom.

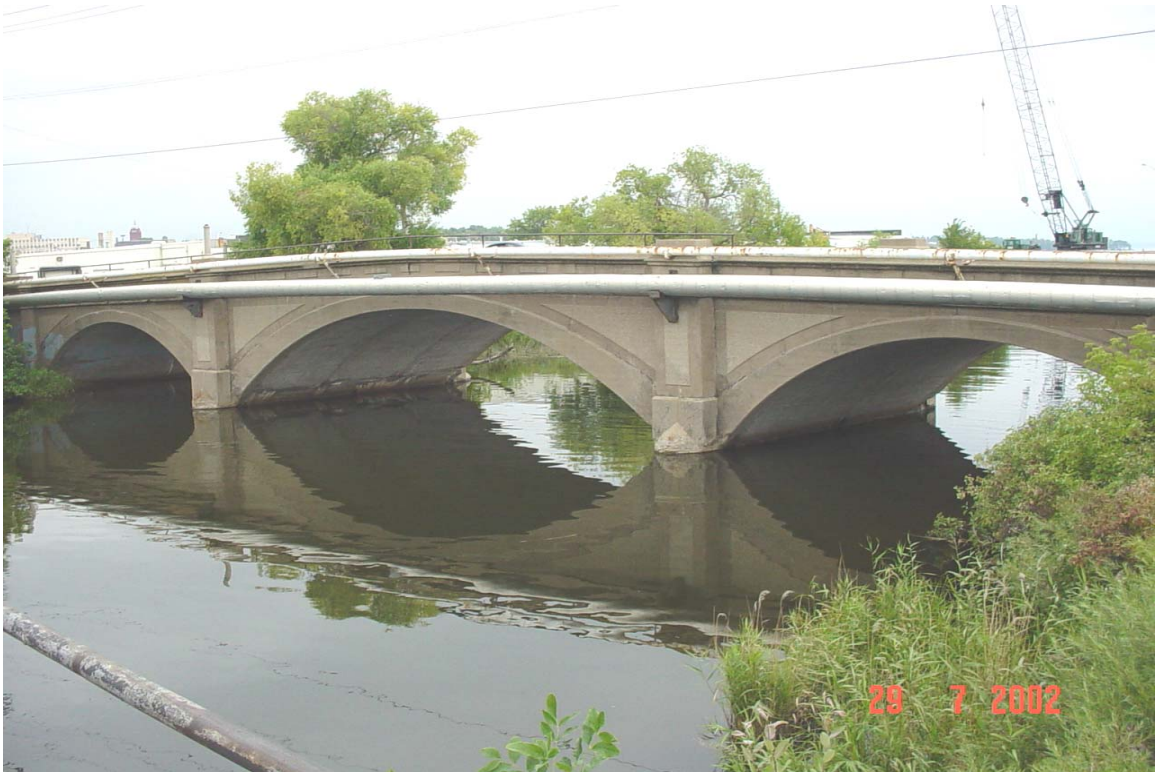
Photograph 1. Overall View of Structure, Looking North.

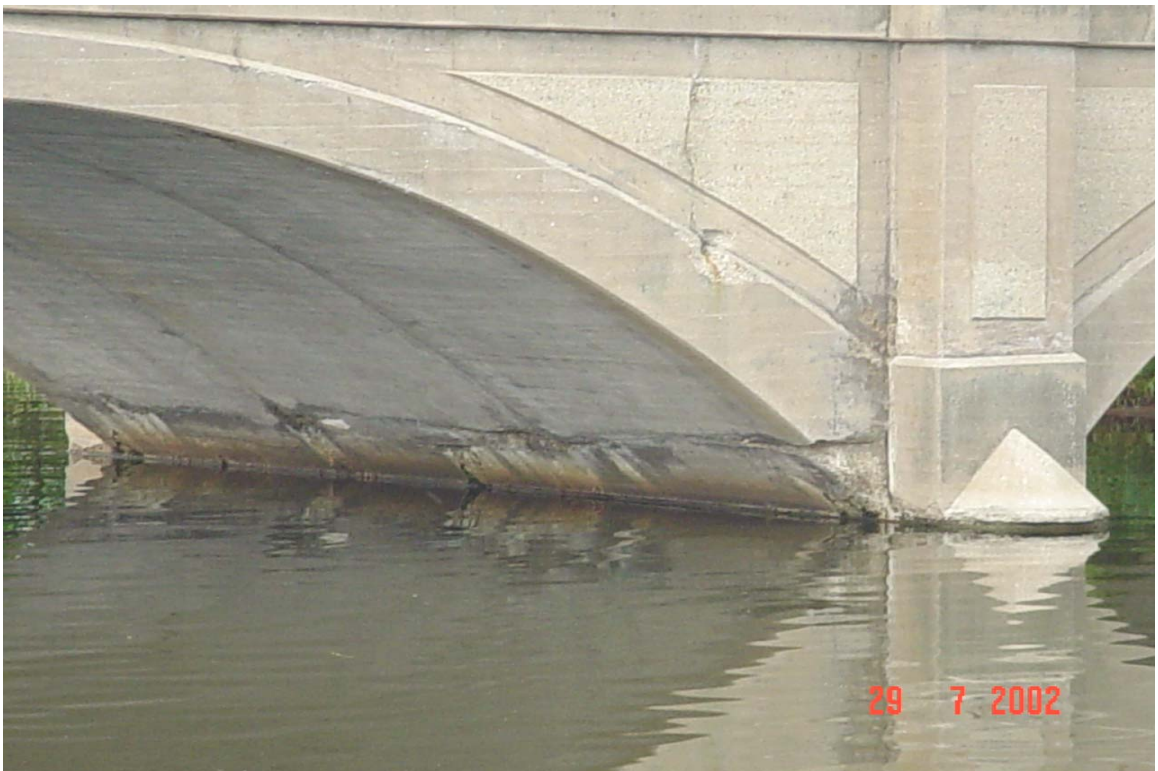
Photograph 2. Overall View of Pier 1, Looking Southwest.

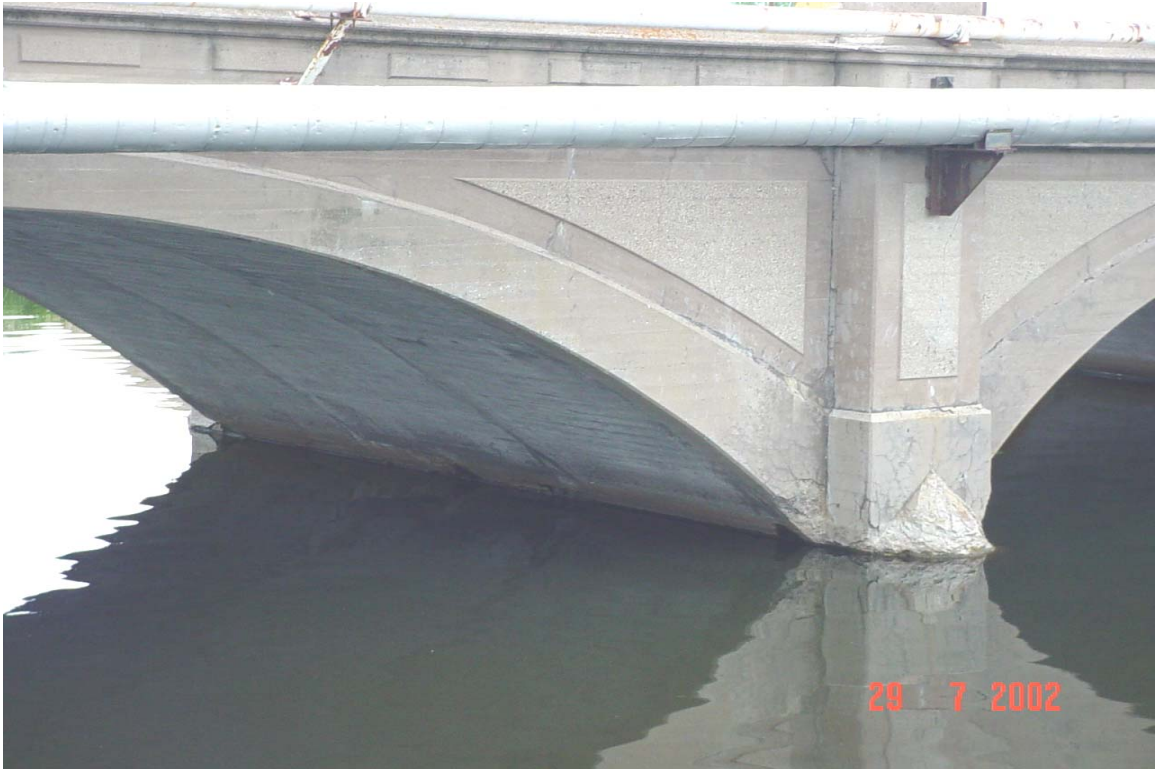
Photograph 3. View of Pier 2, Looking Northeast.

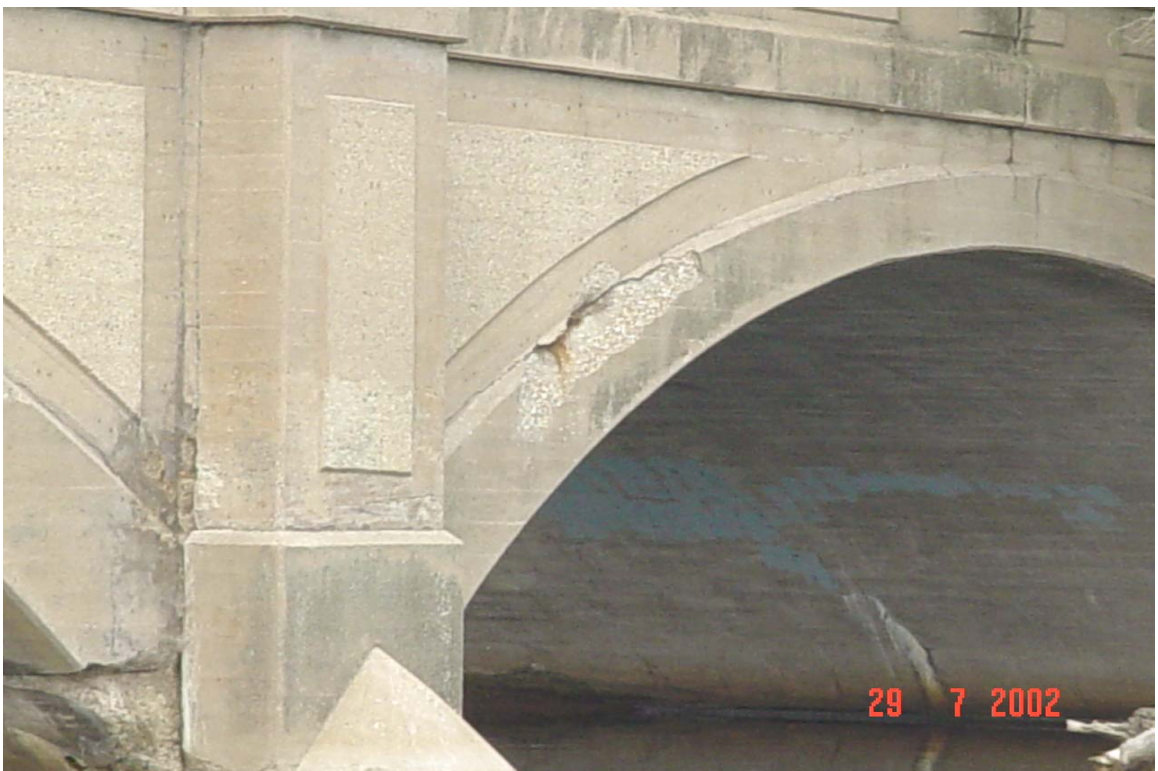
Photograph 4. View of Spall in Spandrel Arch at Pier 1, Looking Southwest.

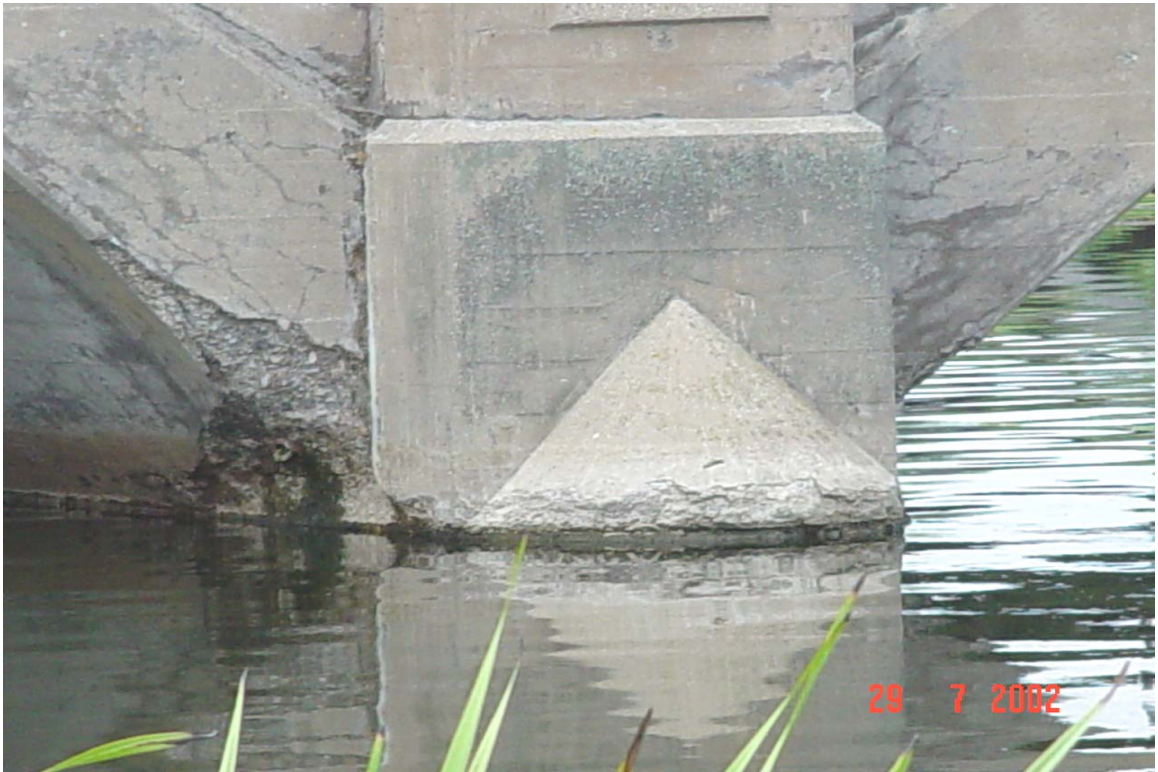
Photograph 5. View of the Downstream Nose of Pier 1, Looking Southwest.

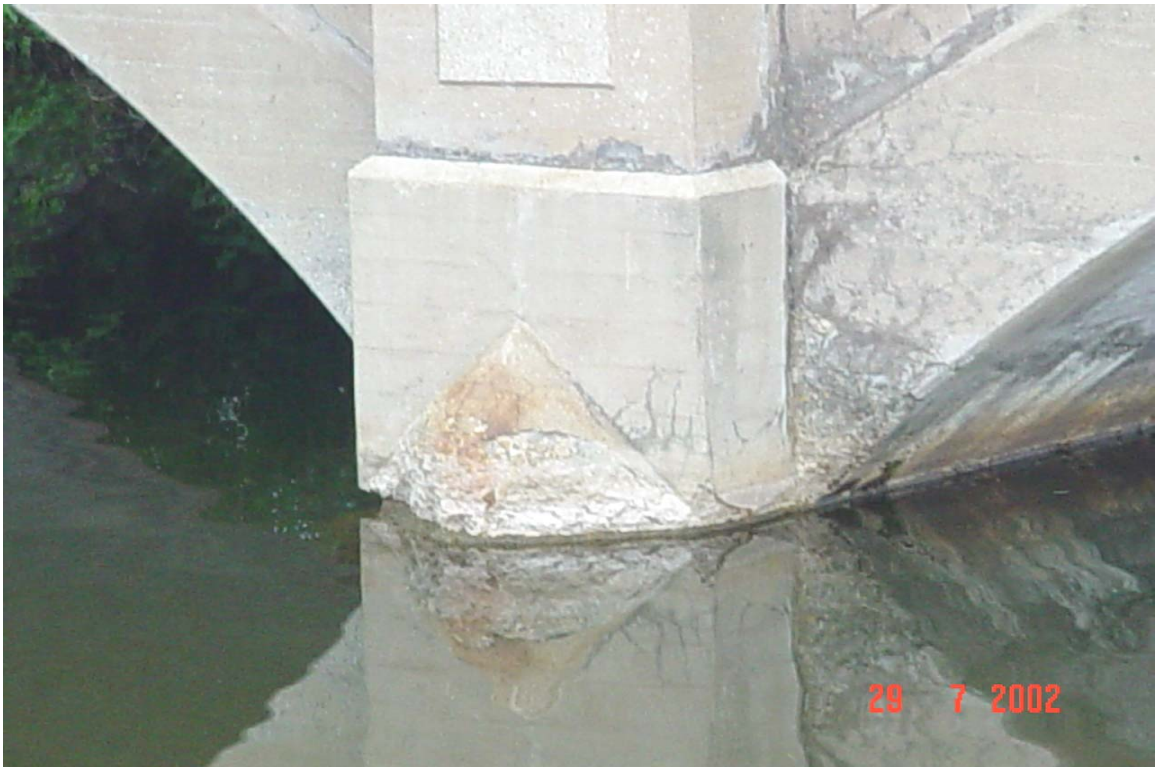
Photograph 6. View of the Upstream Nose of Pier 1, Looking Northeast.

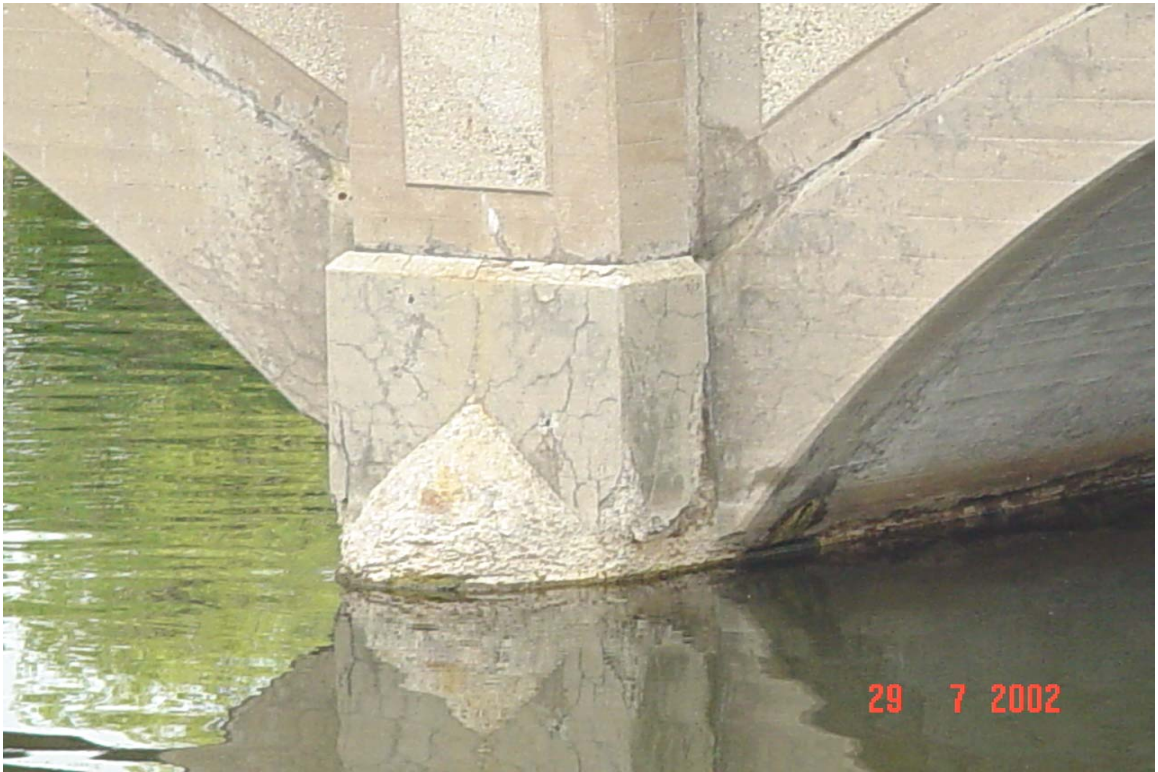
Photograph 7. View of the Upstream Nose of Pier 2, Looking Northeast.

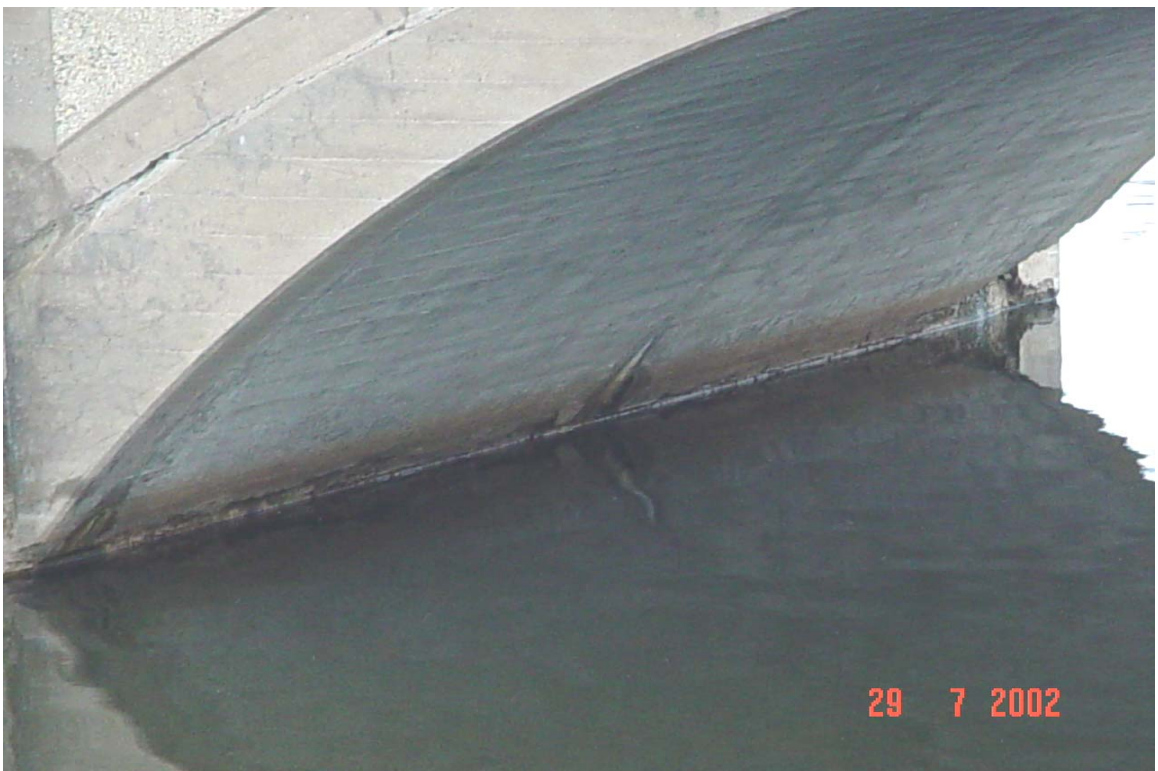
Photograph 8. View of the East Face of Pier 2, Looking Northwest.
